Manhole Inspection Summary

Manhole # S09O__001MH

Insp Date: **4/17/08 9:15 AM**

Location Address: **404 S Caton Ave**

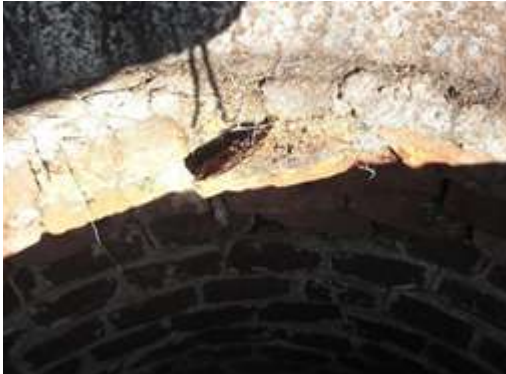
Defect 4

Condition: ☐ Sound ☒ **Cracked** ☒ **Root Intrusion** ☒ **Loose Brick** ☐ Deteriorated

root infiltration from top

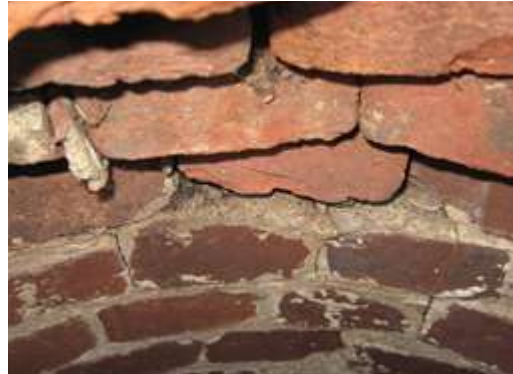
Defect 3

chimney Loose bricks and mortar under frame

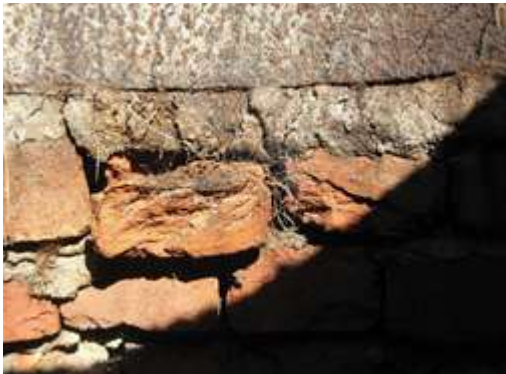
Defect 2

Loose bricks and mortar under frame

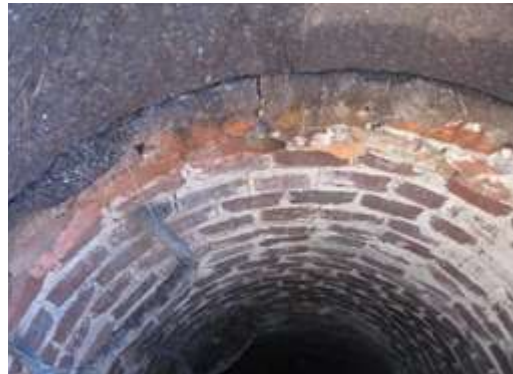
Defect 1

chimney Cracked and missing mortar under frame

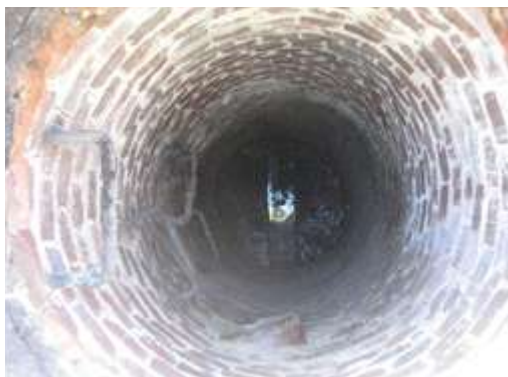
Defect 6

Steps Count: **8** Missing: **0** ☒ **Corroded**

corroded steps

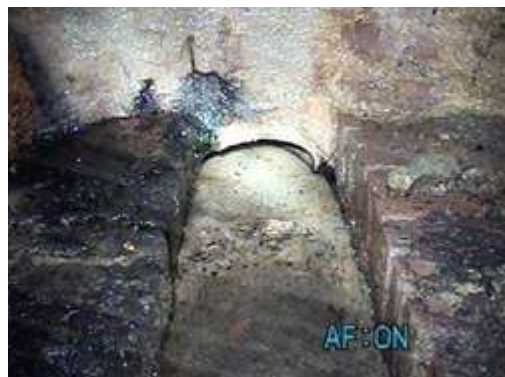
Defect 5

Condition: ☐ Sound ☐ Cracked ☐ Root Intrusion ☐ Deteriorated ☐ Leaks ☒ **Debris**

channel debris

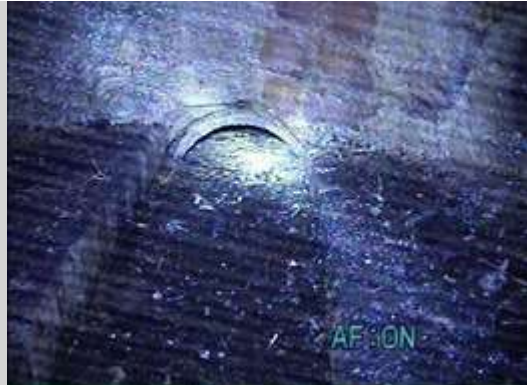
12 O'Clock Outflow

Heavy debris in channel

Pipe Height: **7.2** (in.) Rod and Bar (Angled)
Pipe Material: **Clay** ☐ Pipe Lined
Invert Depth: **14.82** (ft.) Flow Characteristics: **None**
Deposits: ☐ None ☐ Mud ☒ **Sludge** ☒ **Debris** ☐ Grease
Silt Depth: **8** (in.) Deposits Extent: **Heavy**
Infiltration: **None** Pipe Seal Cond: **Sound**

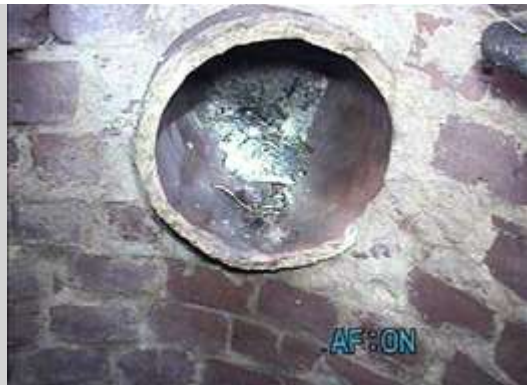
6 O'Clock Inflow

Sediment in pipe

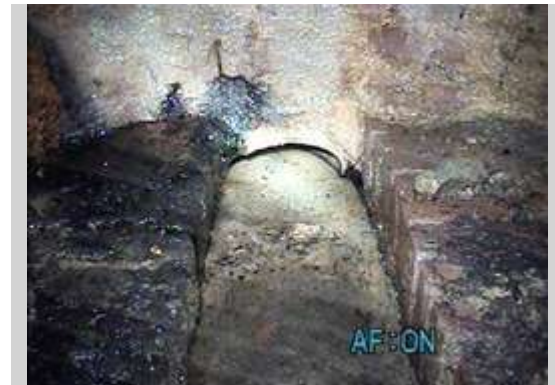
Drop In @ 6 OClock

Heavy debris in channel

Pipe Height: **7.2** (in.) Rod and Bar (Angled)
Pipe Material: **Clay** ☐ Pipe Lined
Invert Depth: **4.11** (ft.) Flow Characteristics: **None**
Deposits: ☐ None ☐ Mud ☒ **Sludge** ☒ **Debris** ☐ Grease
Silt Depth: **8** (in.) Deposits Extent: **Heavy**
Infiltration: **None** Pipe Seal Cond: **Sound**

Drop: **Inside** Rod and Bar
Angled: **Yes** Reading: **13.70** (ft.)
Inv Depth: **14.70** (ft.)
Drop Condition: **Clogged**
